FINAL F.I.R.T.A. REPORT

FISH ATTRACTING SYSTEM

**Title of Project :** Fish Attracting System.

**Proposal :** To study the use of mid-water and surface structures (Fish Aggregating Devices- F.A.D.'s) in attracting commercial species of pelagic fish in economic quantities.

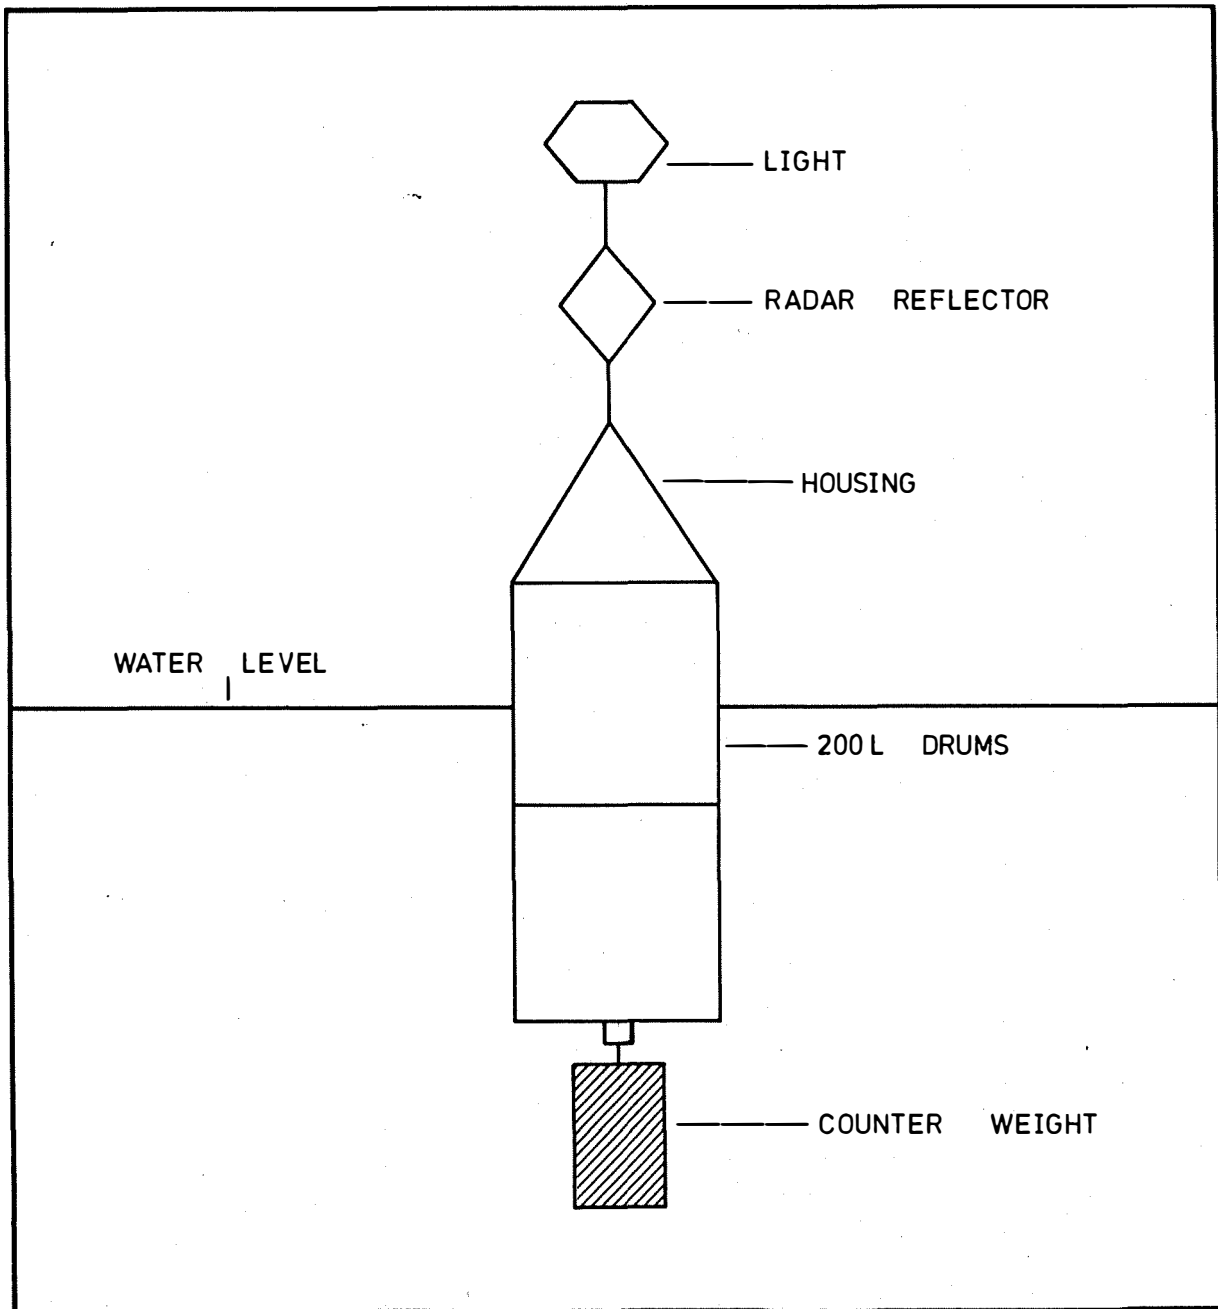
FIG.1 DESIGN FOR TYPE 1 BUOY.

Type 1. 2 two hundred litre galvanised steel drums joined end to end with an external counterweight (Fig 1).

Type 1 buoys were used in the early stages of the

programme but were found to be difficult to locate by sight and were modified by the addition of P.V.C. buoyancy tubes around the upper drum. This increased the stability of the buoy and caused it to ride higher in the water, although the thin walled P.V.C. was easily damaged by shipping or by smaller vessels mooring to the buoy.

The type 1 F.A.D. sat too low in the water, which made locating the buoy in moderate seas difficult. The type 2 buoy solved the problem of visibility but introduced increased shock loading into the mooring system. This buoy also was more complex in design, resulting in more parts which could fail. Similar structures had been used in other states of Australia and overseas. Failures in both of these buoys were attributed to the mooring systems, which were also changed as a result. Concrete blocks were replaced by more dense railway wheels (it is thought that one of the blocks broke on the bottom and allowed its F.A.D. to drift). Because of the possibility of electrolysis, the wire mooring line was replaced by rope. The scope of the mooring was shortened to eliminate rope tangle when using a reverse catenary mooring.

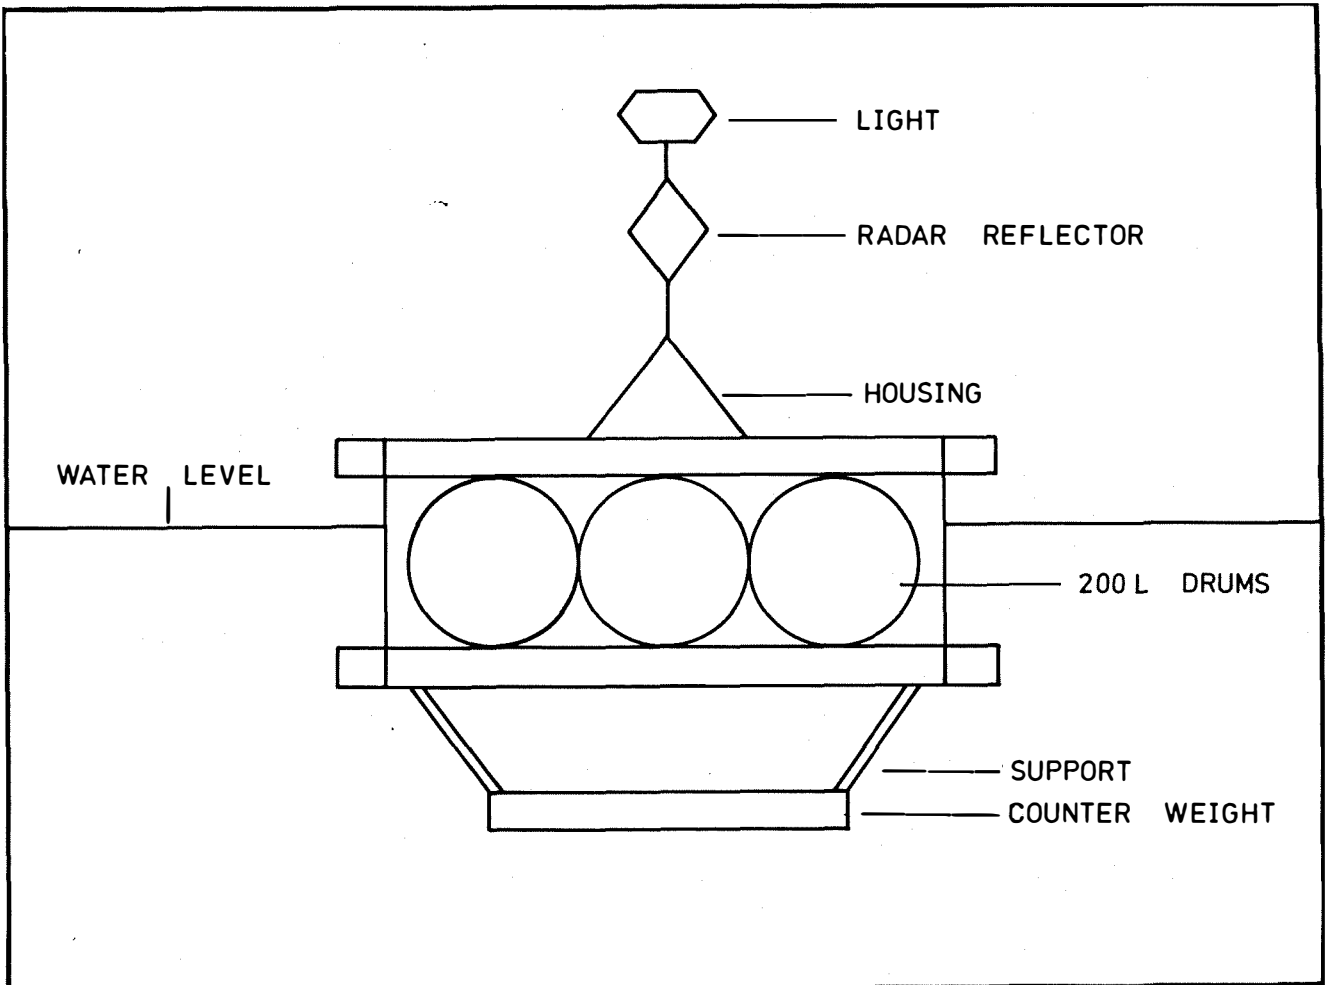
FIG.2 DESIGN FOR TYPE 2 BUOY.

Type 2. 3 two hundred litre galvanised steel drums joined side by side, to form a raft, with an external counterweight (Fig 2).

Type 2 buoys replaced type 1 because of losses, developments overseas and the relatively fragile nature of the extra buoyancy tubes. The type 2 buoy utilised a raft construction of 3 two hundred litre drums bolted together in a hardwood frame. A steel counterweight was attached under this frame and a rolled steel cone was placed on top of the raft to house the battery, light and radar reflector.

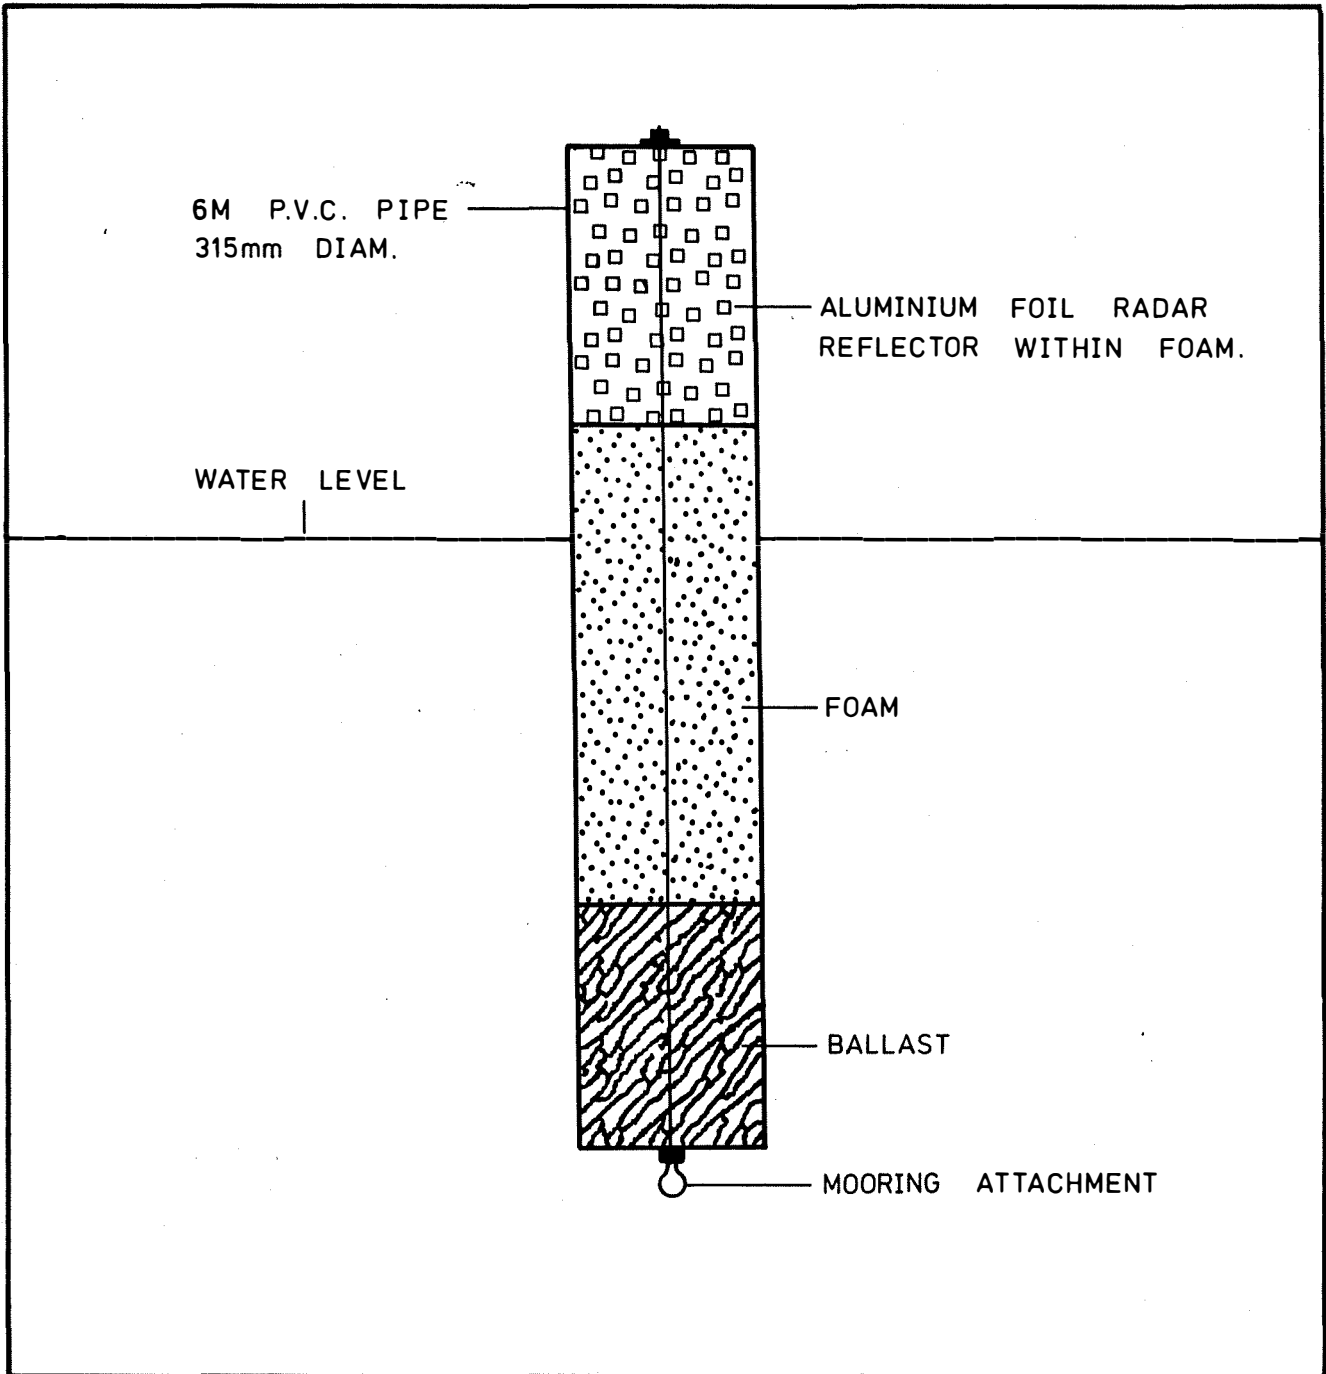
FIG. 3 DESIGN FOR TYPE 3 BUOY.

Type 3. A spar buoy constructed from P.V.C. pipe with an internal counterweight (Fig 3). Type 3a used a separate chain from which to hang the attractor, rather than the mooring chain. (Fig 4).

A single type 3 buoy design had been used successfully in the mid 1970's to mark an artificial reef off Narrabeen. The Coastal Engineering Section of the Public Works Department was contacted and recommended a change from the raft style type 2 buoy to a spar buoy. They considered that the raft placed excessive strain, in the form of shock loading, into the mooring line. Raft buoys had been used successfully in Hawaii, but currents off the New South Wales coast were found to be too great for similar designs. A spar buoy tends to negate this problem.

The spar buoy was constructed from a 6m length of 315mm diam. heavy duty P.V.C. sewer pipe. The end caps were fabricated

from rings of the pipe glued to discs cut from 18mm thick sheet P.V.C.. An 18mm diam. steel rod passed through the centre of the end caps and the pipe with a loop on one end and a nut on the other. Ballast was placed in the lower end, a radar reflector in the top and the pipe filled with closed cell foam.

The final structure used (type 3 and 3a) was designed to ease the shock loading in the mooring system, and to provide an easily visible mark for fishermen. It is also a very simple structure with few parts to fail.

Losses of the type 3 and 3a systems (type 3a used a separate attractor chain) were attributed to failures in the bottom chain, since no corrosion or wear was ever observed in the

top chain. It is therefore recommended that the mooring be lifted within 5 months of placement to check for wear and replace gear as necessary. If this is done, then it is predicted that this final design should remain in place for much longer periods than were observed during this study.

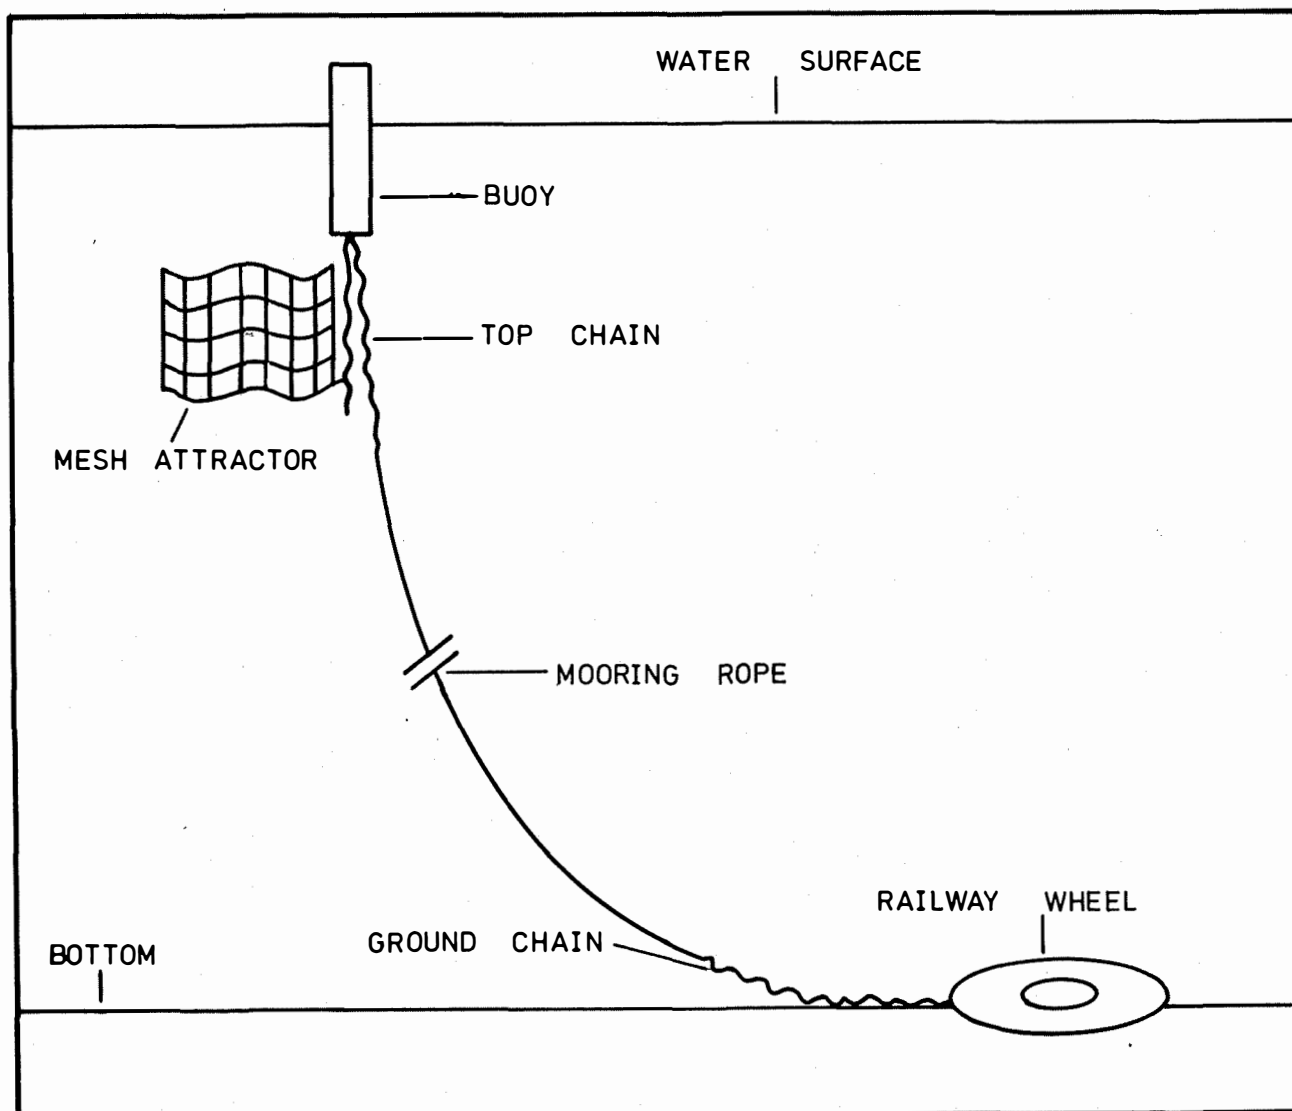
FIG. 4 DESIGN FOR TYPE 3a SYSTEM.

(D) Attractor Design : The attractors used were 21 ply 40mm polyethylene netting hung from the top mooring chain (F.A.D. No's 1 to 14). The netting was replaced by 45mm welded cross-strip plastic webbing (used by the Department of Main Roads as safety fencing) and hung on a separate chain for F.A.D No's 14 to 18 (Fig 4).

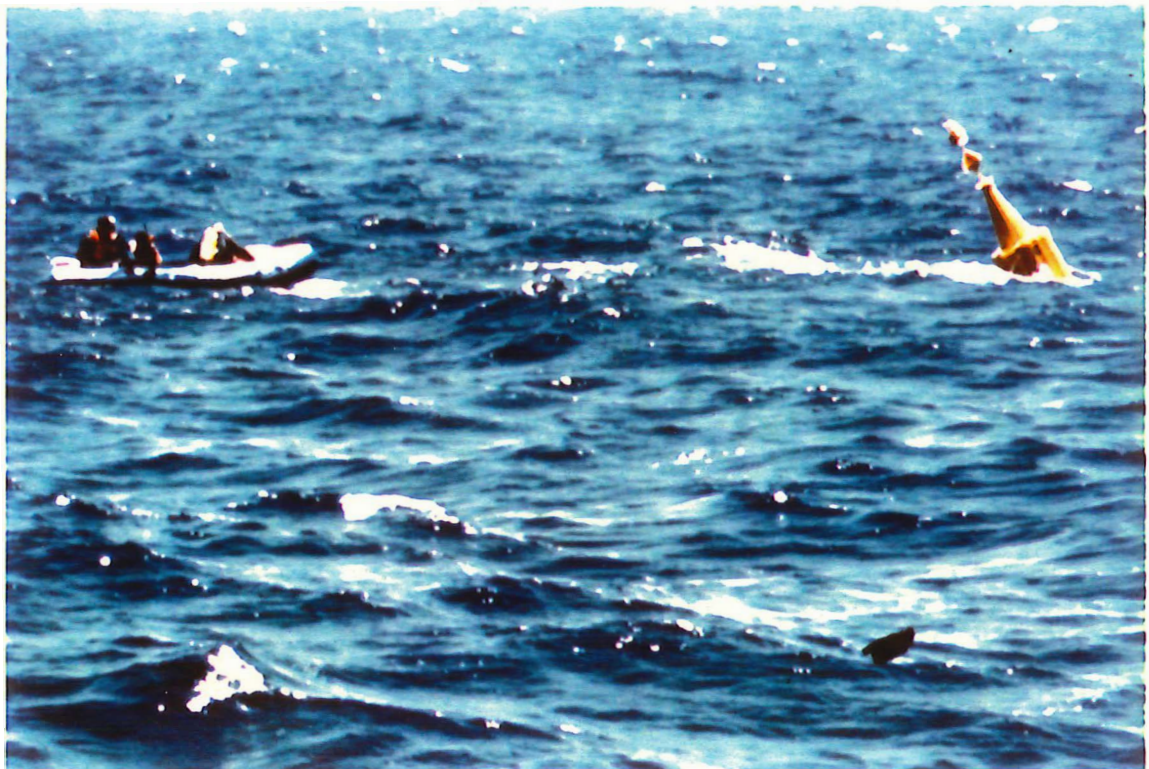
TYPE 1 F.A.D. IN A 3 KNOT CURRENT

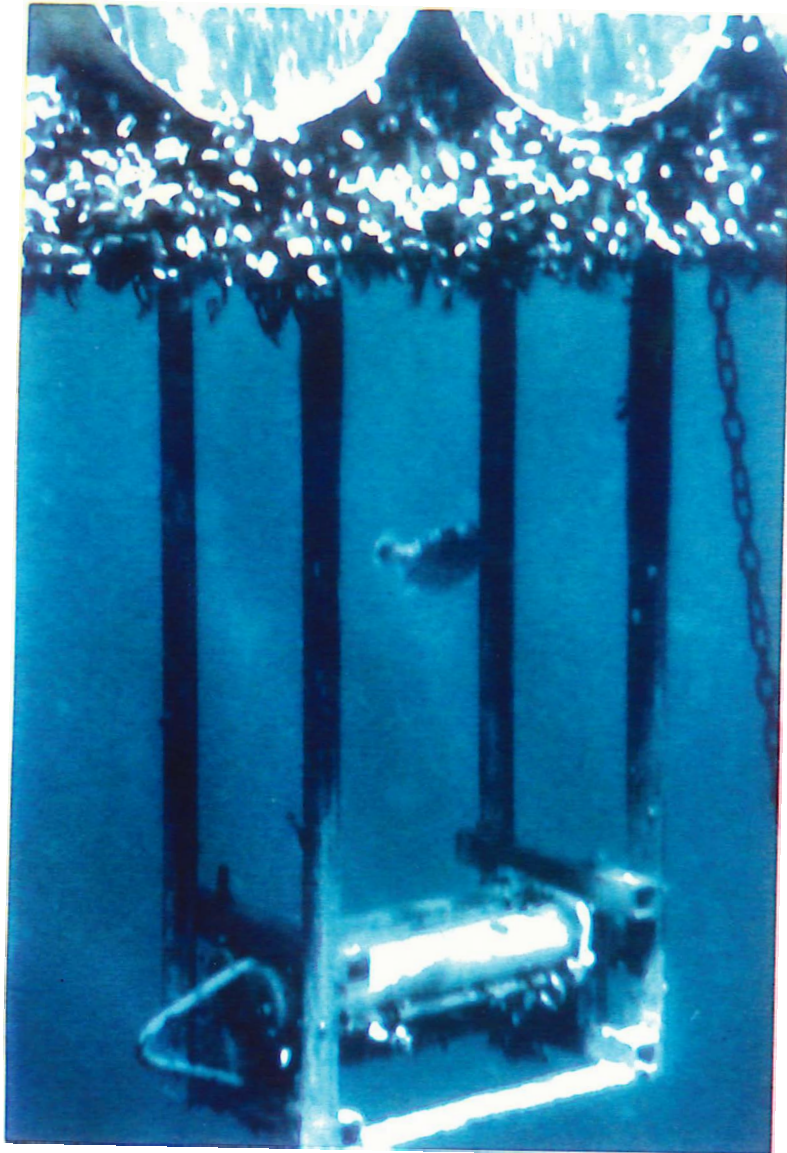
TYPE 2 F.A.D. SHOWING GROWTH
